Manhole Inspection Summary

Manhole # S35KK_032MH

Location Address: **1816 BARCLAY ST**

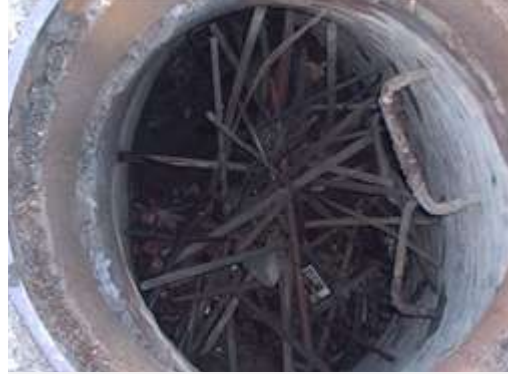
Top View

Frame offset. Corroded steps. Channel debris.

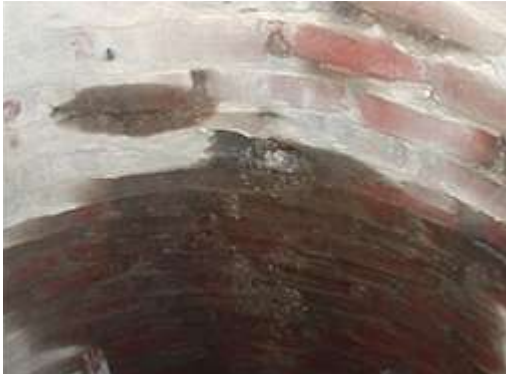
Defect

Condition: ☐ Sound ☐ Cracked ☐ Root Intrusion ☐ Loose Brick ☒ **Deteriorated**

Infiltration: ☐ None ☐ Joint ☐ Cracks ☒ **Mortar** ☐ Roots ☒ **Wall**

Barrel deterioration and infiltration.

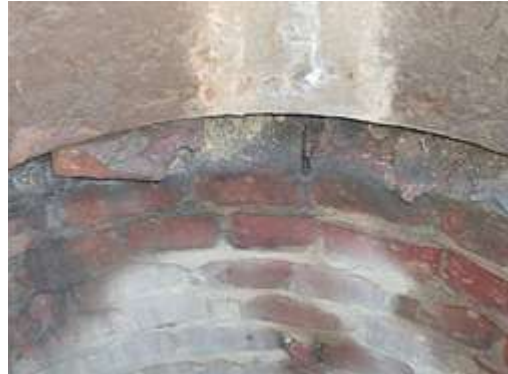
Defect

Condition: ☐ Sound ☐ Cracked ☐ Root Intrusion ☒ **Loose Brick** ☒ **Deteriorated**

Infiltration: ☐ None ☒ **Joint** ☐ Cracks ☒ **Mortar** ☐ Roots ☐ Wall

Frame leaks. Corbel deterioration, loose brick and infiltration.

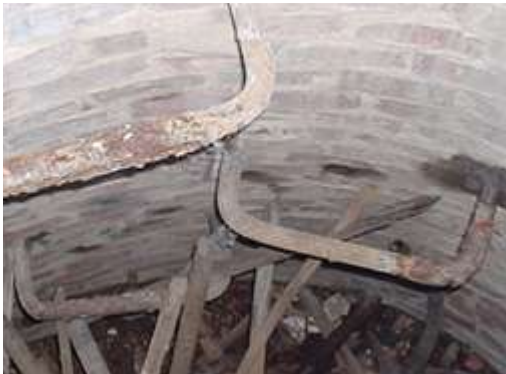
Defect

Barrel infiltration.

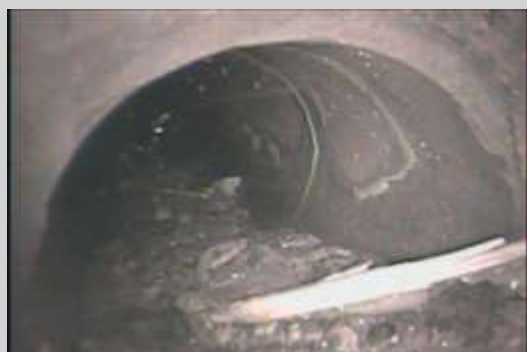
Pipe Out @ 12 O'Clock

Deposits: ☐ None ☒ **Mud** ☐ Sludge ☒ **Debris** ☐ Grease

Silt Depth: **2** (in.)

Deposits Extent: **Medium**
